# MAINTENANCE BULLETIN

NO. 162  
JUNE 1999

## ALFA COMPANY

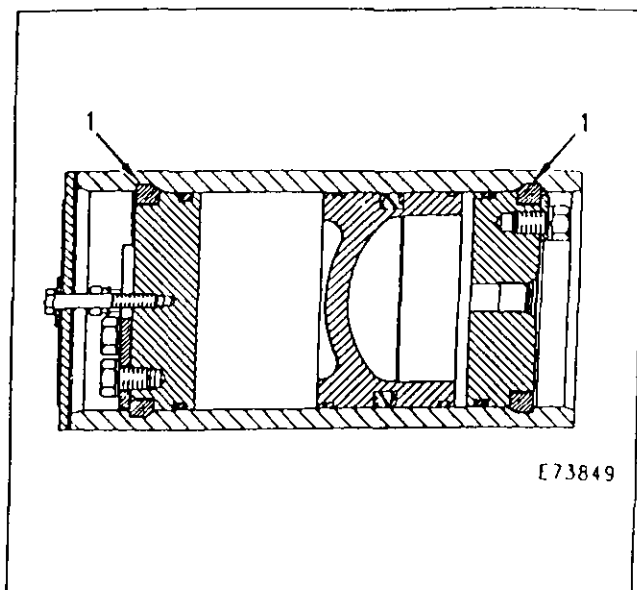
E73849

9J 4018 and 9J 4019 Retaining Rings (no longer serviced) are replaced with 149-3251 Retaining Ring Service Kit (1) for caps in accumulators for cushion blade attachment or brake systems for the following machines.

Typical Accumulator  
(1) 149 3251 Retaining Ring Service Kit

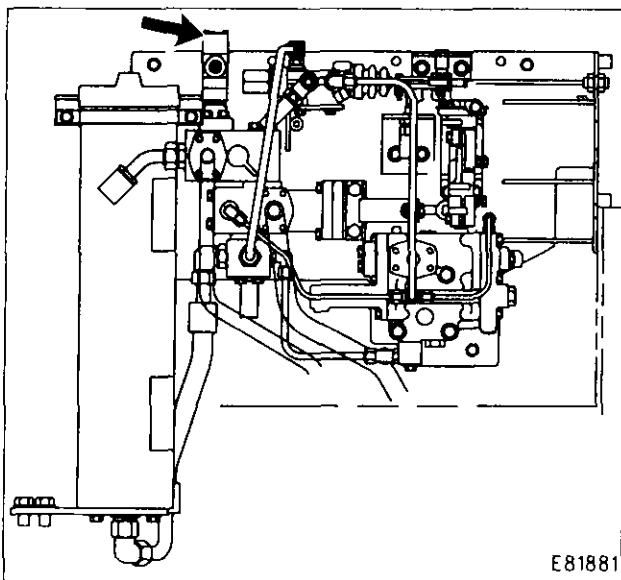
Location of 4E-4521 or 129-4143 Brake Pressure Switch for 988F (8YG) and 988F Series II (2ZR) Wheel Loaders.

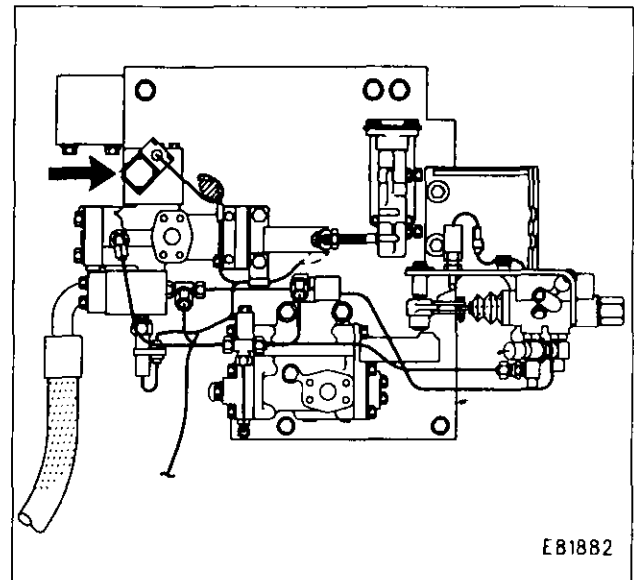
Location of 4E-4521 or 129-4143 Brake Pressure Switch for 992D (7MJ) Wheel Loaders.

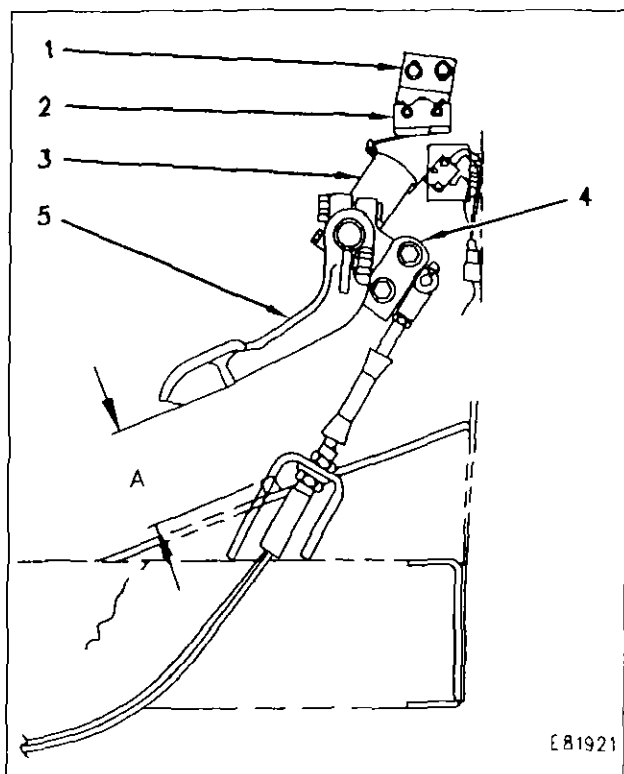
Neutralizer Limit Switch

(1) 125-8242 Plate. (2) 9X-4232 Limit Switch Assembly. (3) 125-8245 Lever. (4) 9K-4929 Angle Assembly. (5) 125-8249 Brake Pedal. (A)  $82.6 \pm 1.5$  mm ( $3.25 \pm .06$  in).

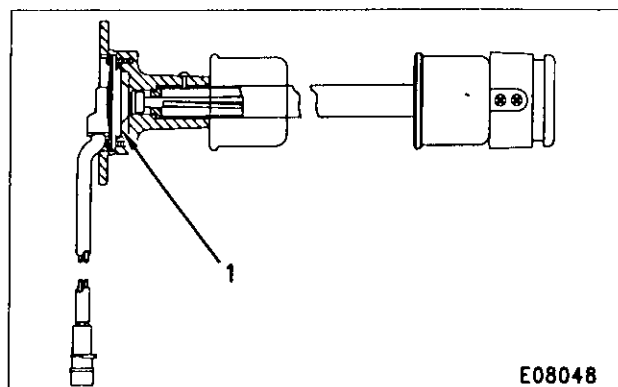
**Description Of Change:** The sensor-dials resistive elements in the fuel level senders have been improved internally to prevent intermittent or open conditions.

Illustration 1: Typical Sensor-Dial location (1).

The location of the sensor-dial is shown in Illustration 1. To check effectivity for the machine being serviced, and to find the correct Fuel Level Sender Assembly part number and improved Sensor-Dial part number, refer to Chart 2. This is a partial list of effective serial numbers because not all effective serial numbers are known at this time. As a reference, the sensor-dial will read approximately 64 to 255 ohms at the empty position and 0 to 29 ohms at the full position (varies depending on part number-see Chart 3) when using the Caterpillar 6V-7070 Multimeter or equivalent. Typically, the sensor-dial is all that needs to be replaced on a malfunctioning sender assembly.

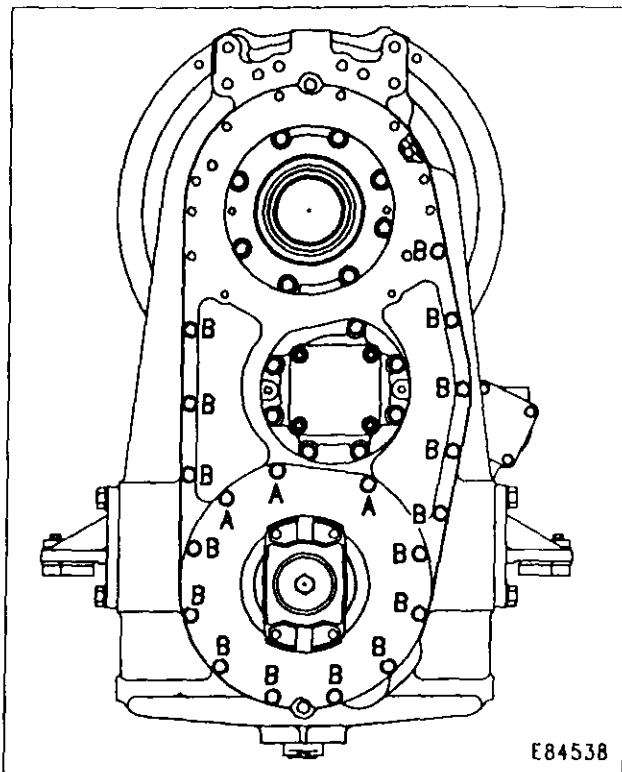
Transfer Case and Gear Group

**Description Of Change:** Three bolts that help hold the bearing cage onto the transfer case assembly have been replaced by three longer bolts and three spacers. The torque for the three new bolts (A) and existing bolts (B) has increased from  $105 \pm 20 \text{ N}\cdot\text{m}$  ( $75 \pm 15 \text{ lb ft}$ ) to a torque of  $135 \pm 20 \text{ N}\cdot\text{m}$  ( $100 \pm 15 \text{ lb ft}$ ). The three longer bolts and higher bolt torque will reduce oil leaks between the transfer case and cover assembly.

**Adaptable To:** Three OS-1587 Bolts (A) replace three former 7B-3235 Bolts. Three new 170-7309 Spacers and three 5P-8245 Washers are used with OS-1587 Bolts (A). The new bolts and bolt torque are effective with the transmissions listed in the Table and adaptable to first production for the machines listed.

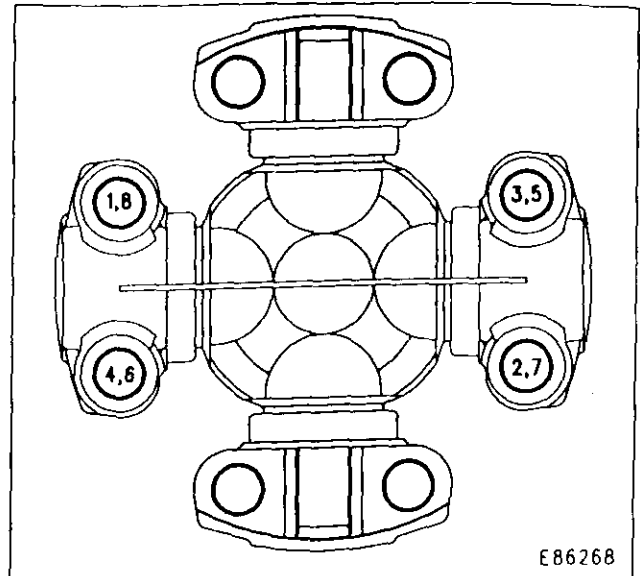
Typical Spider and Bearing Group

**Description Of Change:** A new tightening procedure is being used for all drive line bolts. This tightening procedure reduces the incidence of loose bolts due to uneven bolt tightening or difficult drive line component fit-up.

1. First tighten the bolts using cross pattern sequence (1, 2, 3, 4). Use a torque wrench that is set to the correct torque. This ensures component fit-up and closes any gaps in the assembly.
2. Tighten the bolts again using cross pattern sequence (5, 6, 7, 8). Use a torque wrench that is set to the correct torque. This ensures even bolt tightening.
